UNDERWATER FACILITIES

INSPECTION AND ASSESSMENT

**DEPERMING PIER  
TRIDENT REFIT FACILITY  
BANGOR, WASHINGTON**

January, 1985

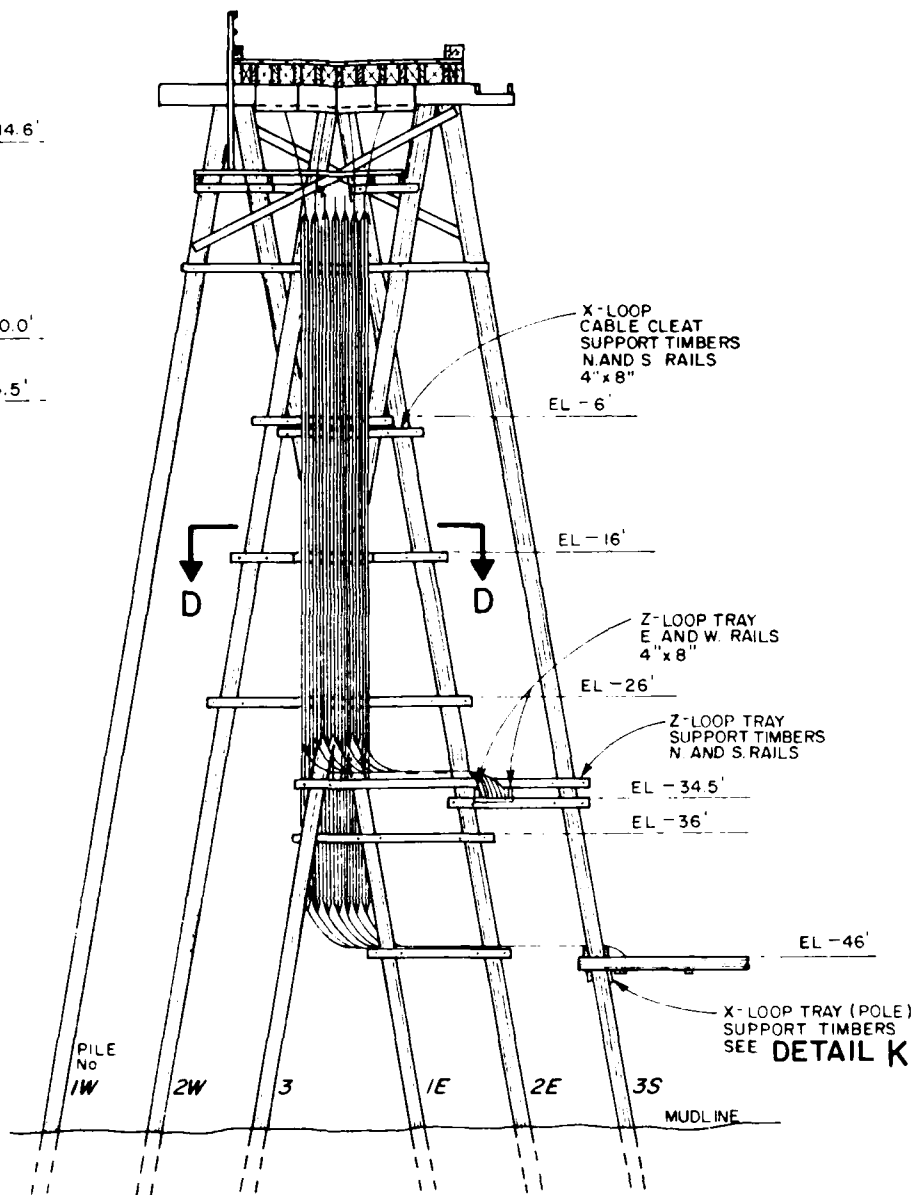
### SECTION C-C WEST PIER - BENT 77

The miscellaneous timbers covered by this inspection include the Z-loop clamp timbers located at Bent 40 and 77 of the East Pier and Bent 39 and 77 of the West Pier. As illustrated on Drawing 2, Section D-D and Detail E, these timbers serve to support the massive bundles of Z-loop cables that run into/out of the water at these locations. In addition to the above Z-loop clamping timbers, the miscellaneous component of the inspection also included the above noted Z-loop troughs (poles) plus trough supports which span Bents 76W-76F and 77W to 77E and the trough bottom timbers along the Z-loop troughs. For further details on these members, see Table 6 and Drawing 2, Section C-C.
